# Manhole Inspection Summary

Manhole # S37E\_\_028MH

Insp Date: **8/25/09 8:20 PM**

**Location** Address: **E.Lexington St.**

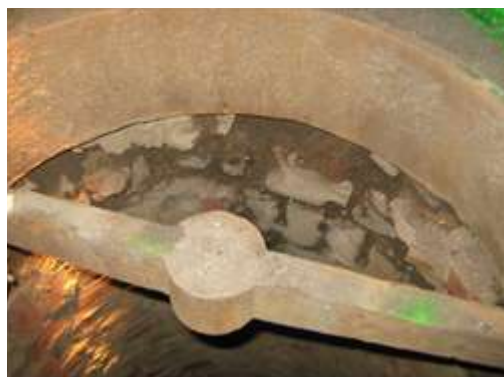
Defect 4

Condition: ☐ Sound ☐ Cracked ☐ Root Intrusion ☐ Loose Brick ☒ **Deteriorated**

Infiltration: ☐ None ☐ Joint ☐ Cracks ☒ **Mortar** ☐ Roots ☐ Wall

deteriorated chimney with infiltration from mortar

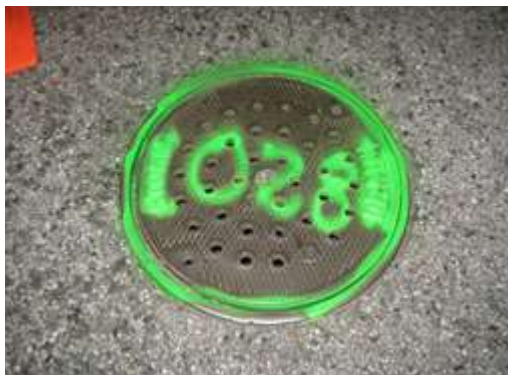
Defect 2

Type: **Stormwater** Condition: **Sound** Cover Material: **Cast Iron**

incorrect lid

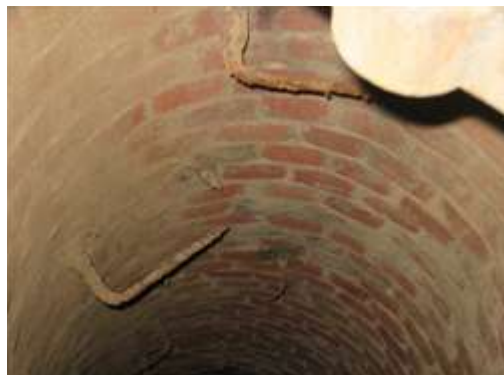
Defect 5

**Steps** Count: **9** Missing: **1** ☒ **Corroded**

corroded rung and missing rung

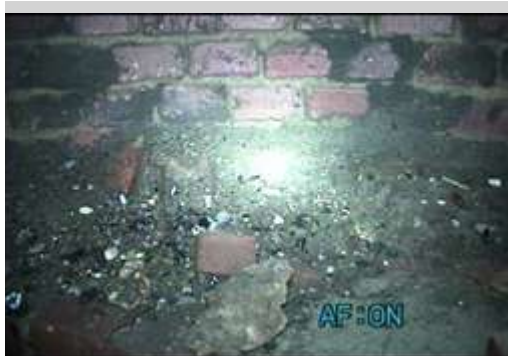
### Defect 1

Condition: ☐ Sound ☐ Cracked ☐ Root Intrusion ☐ Deteriorated ☐ Leaks ☒ **Debris**

debris on the bench

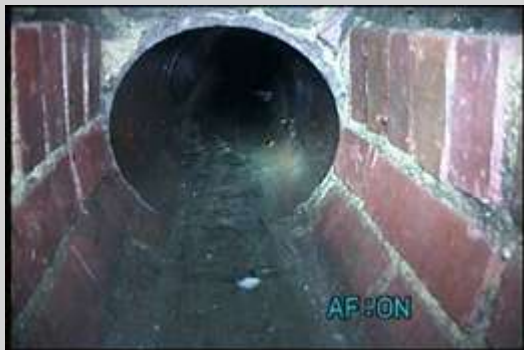
12 O'Clock Outflow

Pipe Height: **10.8** (in.) Rod and Bar (Angled)  
Pipe Material: **Clay** ☐ Pipe Lined  
Invert Depth: **15.22** (ft.) Flow Characteristics: **None**  
Deposits: ☒ None ☐ Mud ☐ Sludge ☐ Debris ☐ Grease  
Silt Depth: **0** (in.) Deposits Extent:  
Infiltration: **None** Pipe Seal Cond: **Sound**

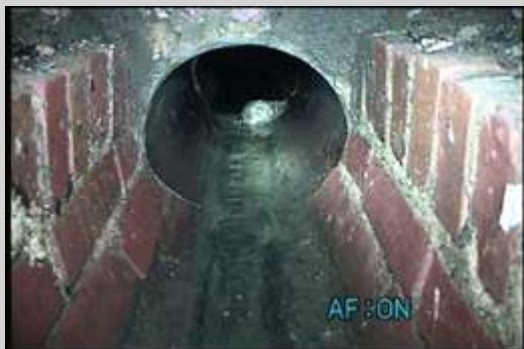
6 O'Clock Inflow

Pipe Height: **10.8** (in.) Rod and Bar (Angled)  
Pipe Material: **Clay** ☐ Pipe Lined  
Invert Depth: **15.16** (ft.) Flow Characteristics: **None**  
Deposits: ☒ None ☐ Mud ☐ Sludge ☐ Debris ☐ Grease  
Silt Depth: **0** (in.) Deposits Extent:  
Infiltration: **None** Pipe Seal Cond: **Sound**
